MOUNTAIN LAKE DAM

NDI ID NO. PA-00546

PHASE I INSPECTION REPORT
NATIONAL DAM INSPECTION PROGRAM

JUNE 1980

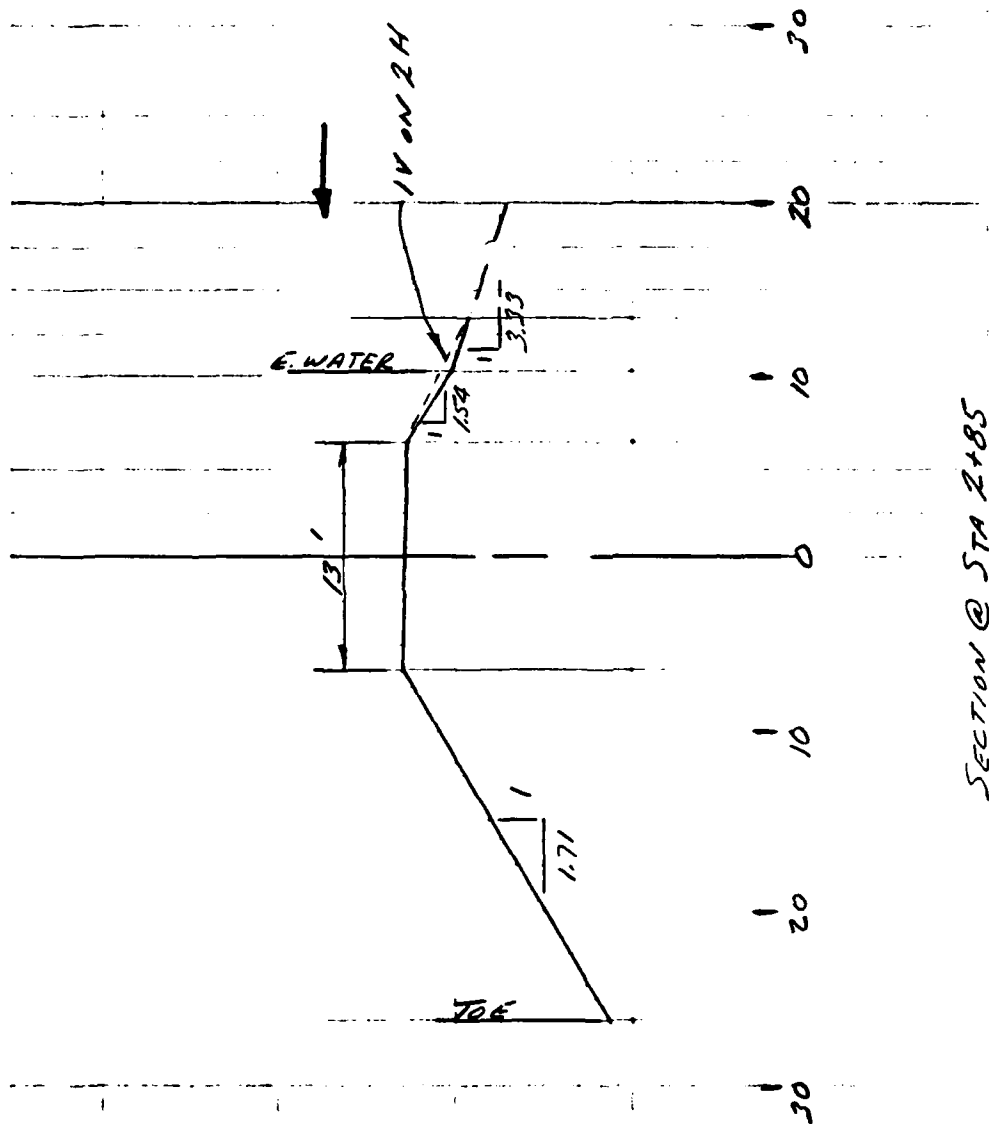
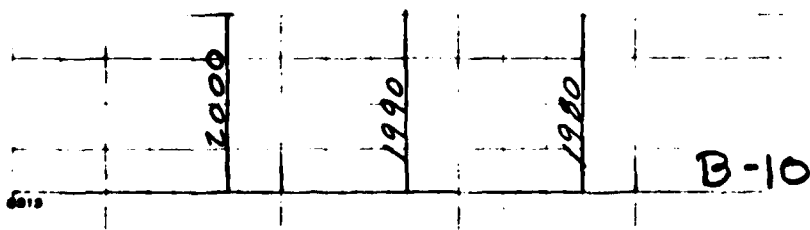
SUBJECT MOUNTAIN LAKE DAM FILE NO. 8202
CROSS SECTION OF EMBANKMENT SHEET NO. 2 OF 2 SHEETS
FOR _____
COMPUTED BY DLE DATE 4-30 CHECKED BY _____ DATE _____

THE UPPER PART OF THE UPSTREAM SLOPE AND THE
DOWNSTREAM SLOPE ARE STEEPER THAN THE
REPORTED DESIGN.

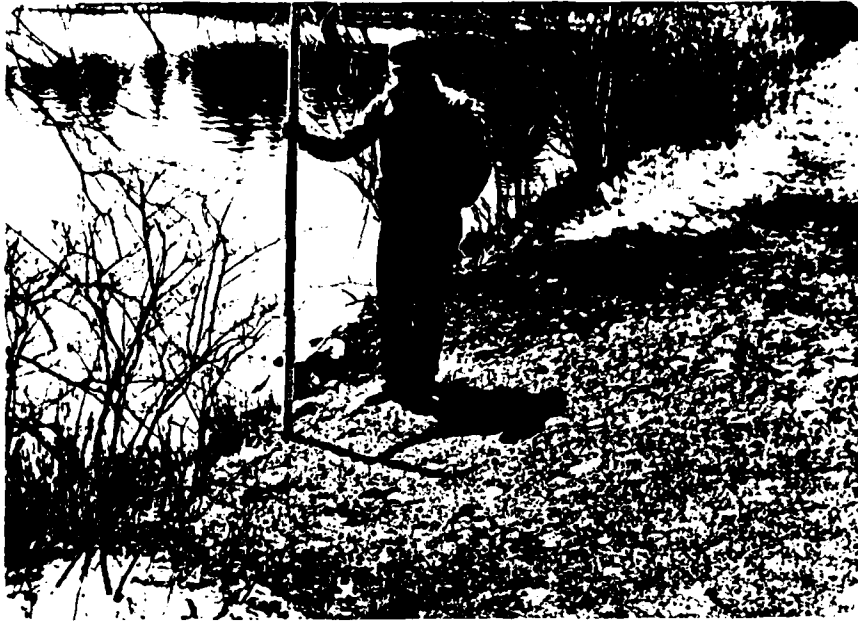
A. Upstream Slope

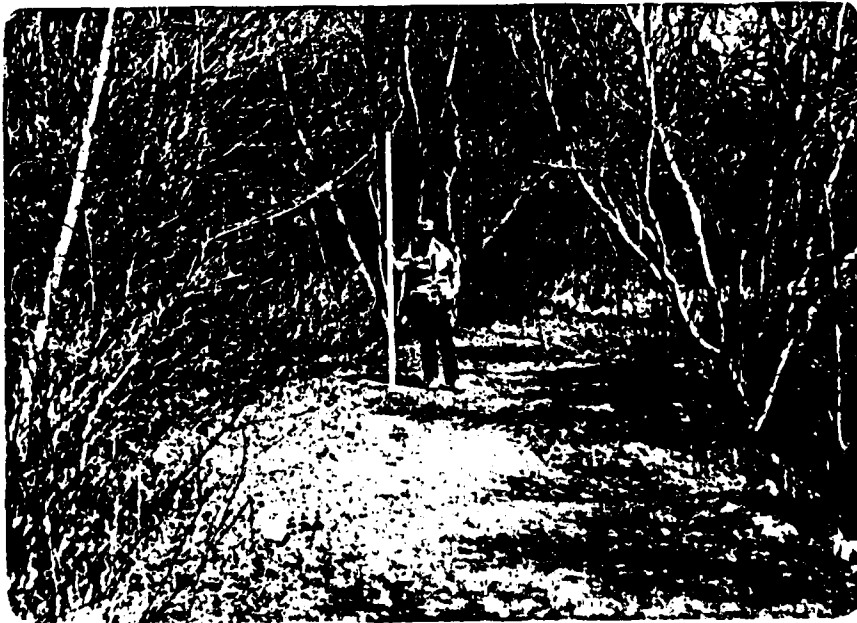
B. Top of Dam

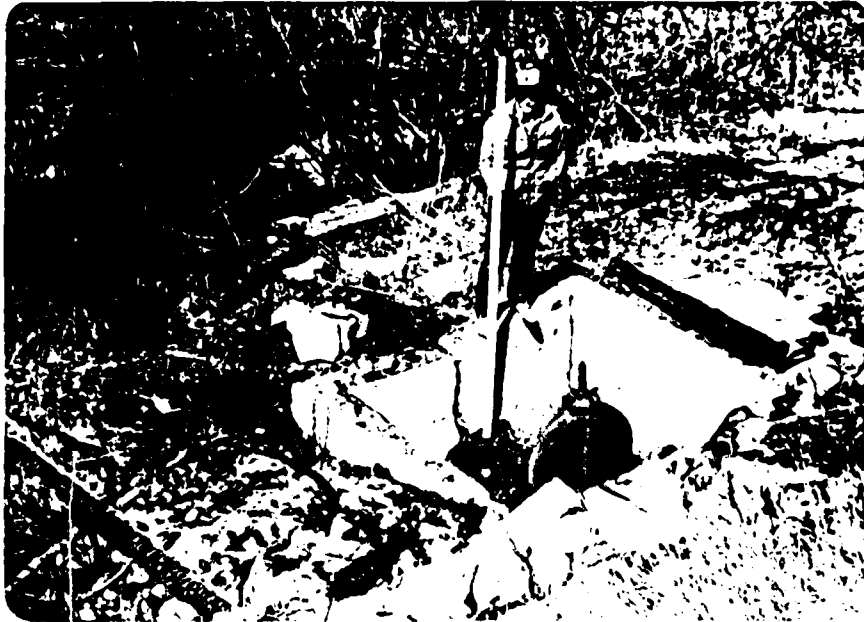
c. Appurtenant Structures. The valve pit at the outlet works is sheared and broken throughout (Photograph E). The nuts securing the gate housing are severely rusted. The Owner's agent offered to operate the outlet works until he discovered that there was no operating mechanism. He did not recollect it ever being operated.

(3) Appurtenant Structures. The valve pit at the outlet works is obviously structurally inadequate. The upstream wall of the pit is at the toe of the embankment. The sheared wall leaves the toe with no support in this area. Because of the severely rusted nuts, it is possible that the gate housing would not be securely attached to the valve, if it were operated. There would then be no effective means of closing the valve. Because there is no protective structure, the valve is susceptible to freezing during the winter.

E. Outlet Works

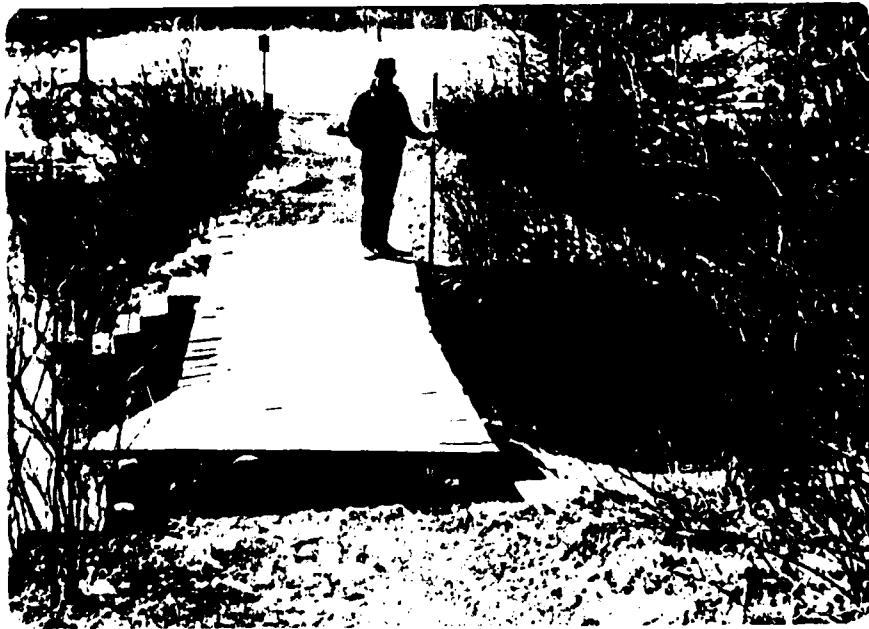
The spillway is in very poor condition. The wooden beams supporting the timber spillway bridge have snapped, leaving the bridge bowed (Photograph F). The bridge is partially supported in the center by a pier constructed of timber and loose stones. To the left of the pier, a 0.9-foot high stoplog extends across the crest (Photograph H). The top 0.4-foot thick layer of concrete has peeled off the crest to the left of the pier. Portions of the peeled concrete lie loosely on the crest. To the right of the pier, a steel I-beam and a rotten log lie skewed to the crest (Photograph G). Upstream from the crest, the left spillway wall is tilted about 30° towards the centerline of the spillway. At the crest, the left wall is cracked through and open. Just downstream, the wall is skewed about 20°. Further downstream, the wall is almost totally undermined along its entire length. The right wall is in slightly better condition, although the part that is just downstream from the crest is skewed about 10° and tilted inward. The right wall upstream of the crest is scoured from 0.1 to 0.2 foot deep. Downstream of the crest, the scoured area is about 1.2 feet high and 0.7 foot deep. At the crest, the wall is cracked and separated.

F. Spillway Bridge

(1) Remove the spillway bridge. Also remove brush and debris from the spillway. Until the recommendations below are completed, provide temporary measures to ensure the structural stability of the spillway.
